Hurricane Performance of Spray Polyurethane Foam Roofing

ROGER V. MORRISON

ABSTRACT

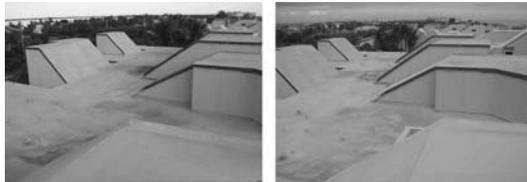
Figure 1: Condominium roof near Jensen Beach. Left photo is before hurricanes Frances and Jeanne. Left photo is after. No damage was observed.

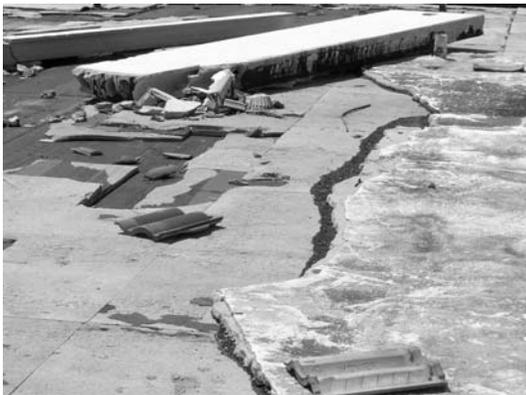
Figure 3: Three modes of failure are evident on this SPF recover of a built-up roof. (1) Deck (hollow-core concrete panels at top); (2) Substrate (built-up roof at left foreground); and (3) Surface Damage (at right foreground).

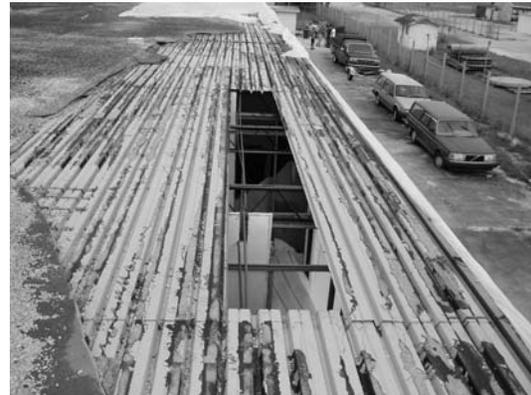
Roof decks are commonly constructed of concrete, steel or plywood. Decks provide the structural support for the waterproofing and insulating components of the roofing system. Deck failure results from high pressure differentials.

Figure 4: Deck failure. An overhead door failed immediately below the location of this deck failure.

When wind encounters an obstruction, such as a building, air pressure tends to increase on the windward side relative to the leeward side. As wind passes over a roof, the velocity increases because the air must travel a greater distance; as air velocity increases, its pressure tends to decrease (similar to air passing over an aircraft wing). Thus, air pressure on the top of the roof tends to be lower than the underside. Exacerbating this effect, if a window or door suddenly fails, the pressure within the building can suddenly and catastrophically spike, blowing off portions of the roof deck which might have otherwise withstood the wind loads. Roof deck failures remove portions of the roofing membrane and insulation and expose building interiors to rain and wind damage.

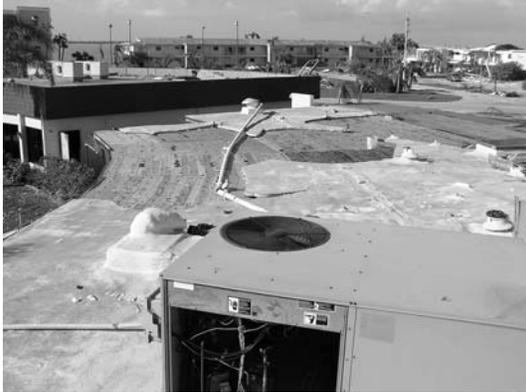
The typical mode of substrate failure was a loosening of the windward edge followed by a peel-back of the membrane. Depending on the security of the underlying insulation, the peel-back may or may not take insulation boards with it. At some point in the peel-back process, the membranes typically ruptures, leaving the remaining substrate and SPF intact.

Figure 5: Substrate failure. Deck remained intact, underlying built-up roof peeled up taking SPF recover with it.

Substrate failure could be minimized or eliminated by improving edge and membrane security when installing SPF roofs. Possible improvements are:

Remove the existing membrane a few feet in at roof edges and then apply SPF directly to the deck in these areas;

Refasten the existing membrane at edges and in the field.

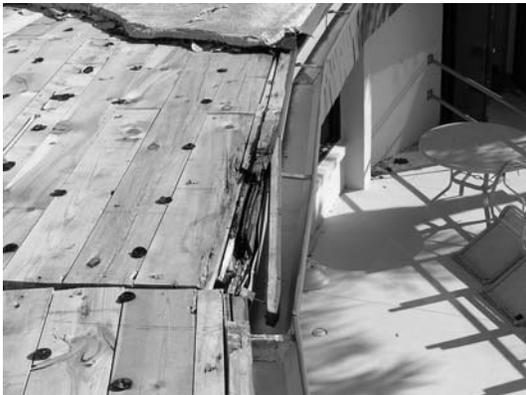
Figure 6: Substrate failure close-up. Edge nailer was rotted and built-up roof was insufficiently fastened.

Substrate failures are due to:

- Insecure edges and
- Insufficient adhesion or fastening of the membrane and insulation boards to the deck.

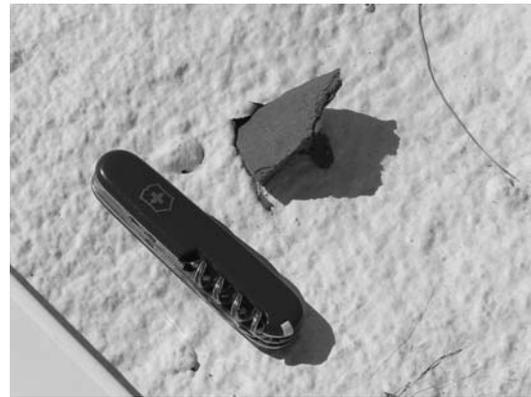
Surface damage of SPF roof systems occurred where wind-borne missiles (such as tree limbs and broken ceramic roof tiles) impacted the SPF. Gravel scour occurred at windward roof corners, and in some cases, near roof protrusions and roof mounted equipment. Little or no loss in waterproofing resulted from surface damage.

Figure 7: Surface damage (missile impact).

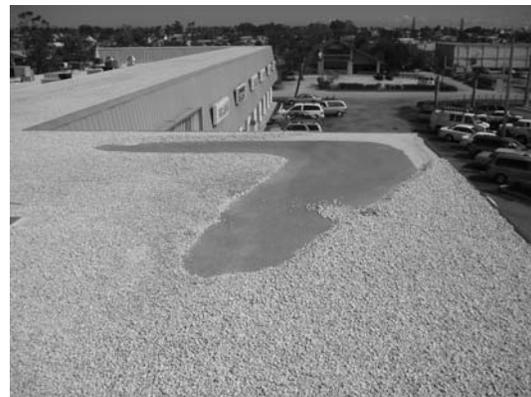
Figure 8: Surface damage (gravel scour).

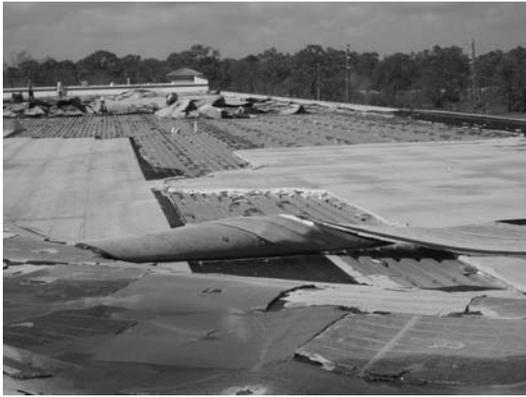
following Frances. In many cases, the SPF patches/repairs withstood the winds of Jeanne better than the remaining areas of the patched conventional roofs.

Figure 9: This SPF patch (right-middle of photo) was installed after Hurricane Frances. Hurricane Jeanne damaged the remaining roof, leaving the SPF patch intact.
